4. TITLE (and Subtisto)	S. TYPE OF REPORT & PERIOD COVERED
FLOOD CONTROL AND IRRIGATION OUTLET WORKS AND TAILRACE CHANNEL FOR NEW MELONES DAM, STANISLAUS RIVER, CALIFORNIA, Hydraulic Model Investigation	Final report. 77
RIVER, CALIFORNIA, Hydraulic model investigation	
AUTHOR(a)	S. CONTRACT OR GRANT NUMBER(a)
Stephen T. Maynord

FLOOD CONTROL AND IRRIGATION OUTLET WORKS AND TAILRACE CHANNEL FOR NEW MELONES DAM

STANISLAUS RIVER, CALIFORNIA

Hydraulic Model Investigation

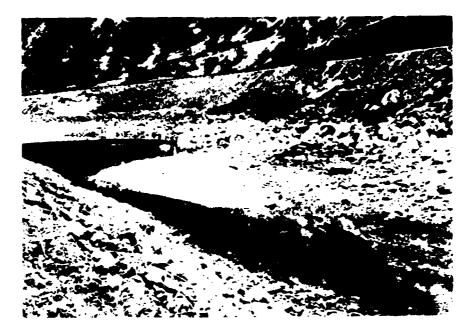
6. During the initial operation of the FC&I, flow from the two 78-in.-diam fixed-cone valves severely eroded the bank opposite the FC&I and powerhouse (Figure 3). These flows were at pool el 804 which is considerably less than the maximum operating pool el 1088. Velocities exiting the FC&I hoods in the original design are approximated by the empirical equation:

These velocities would approach 155 fps at maximum operating conditions. The derrick stone was washed off the opposite bank and deposited in the tailrace channel. A scour hole approximately 15 ft deep developed downstream of the impingement pad. The access road to the powerhouse was in danger of being washed out if operation of the valves had been continued.

a. Closeup of failure of opposite bank

b. Aerial view of failure of opposite bankFigure 3. Initial prototype operation

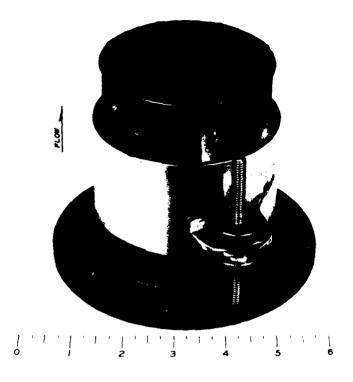
- 11. The discharge characteristics of the model FC&I valves (Figure 5) were determined on a calibration test stand at WES. Knowing the relationship of the head, valve opening, and discharge allowed reproduction of the proper flow conditions in the 1:24-scale model. Flow in the model was provided by pumps, and water-surface elevations were measured by point and staff gages. Velocities were measured by a pitot tube and pressures were measured with a dial-faced-Bourdon-type pressure gage.

Figure 5. Model FC&I valve

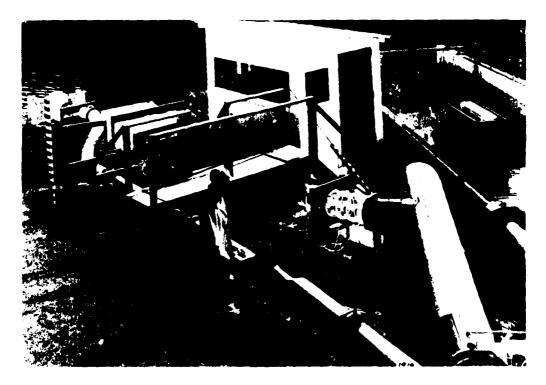
- 33. Testing of several aspects of the deflector plate design was conducted in the 1:12-scale model used in the New Melones fixed-cone valve study (Figure 8). Flow conditions in the 1:12-scale model of the 18-ft-diam hoods are shown in Photos 12 and 13 for pool el 1088 and a 28.1-in. sleeve travel. Flow arrows are shown on the photographs because dye injections did not photograph well in the model. Note the extensive bracing used to stiffen the model test stand.

Figure 8. 1:12-scale model of New Melones fixed-cone valve

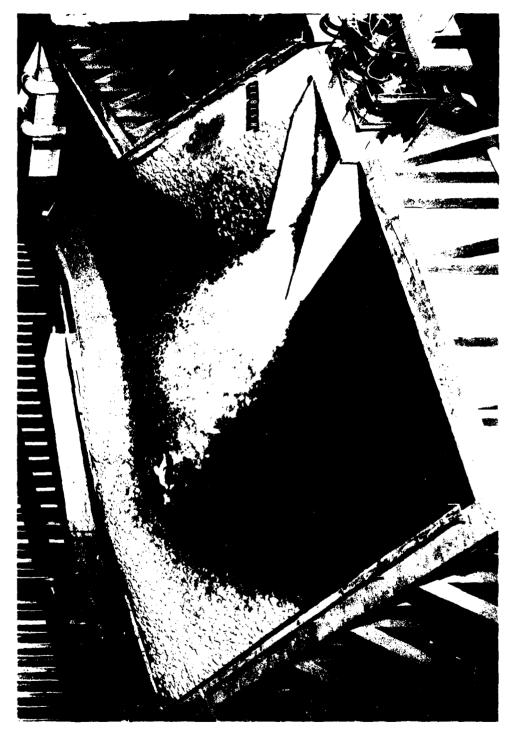
Photo 3. Plunge pool design, impingement pad removed, hood deflector and baffle blocks added; pool el 804, 32.4-in. sleeve travel, minimum tailwater

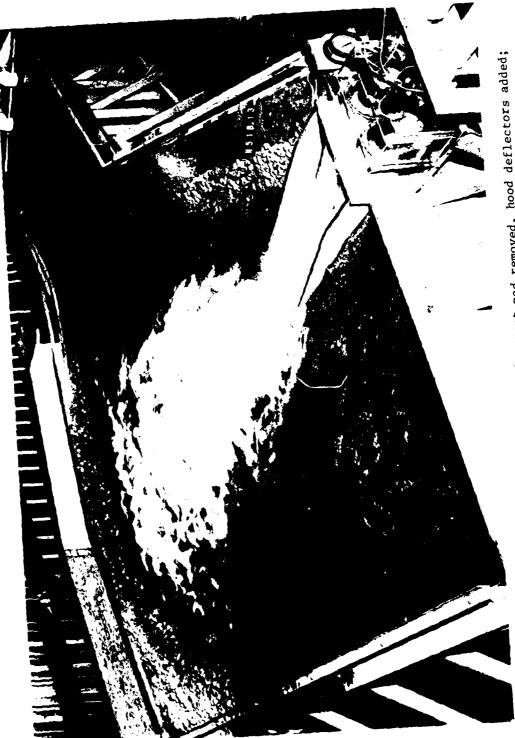
Photo 4. Increased tailwater design, impingement pad removed, hood deflectors added; poot el 1008, 28.1-in. sleeve travel, tailwater el 518

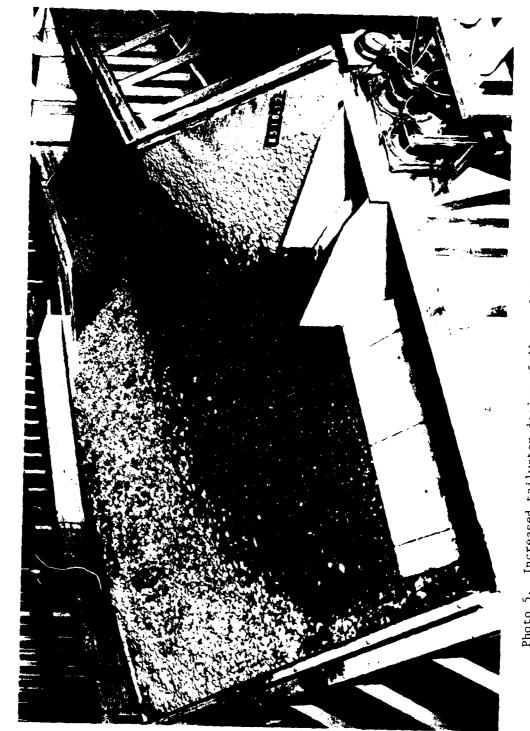
Photo 5. Increased tailwater design, failure of derrick stone on opposite bank after flow conditions shown in Photo 4

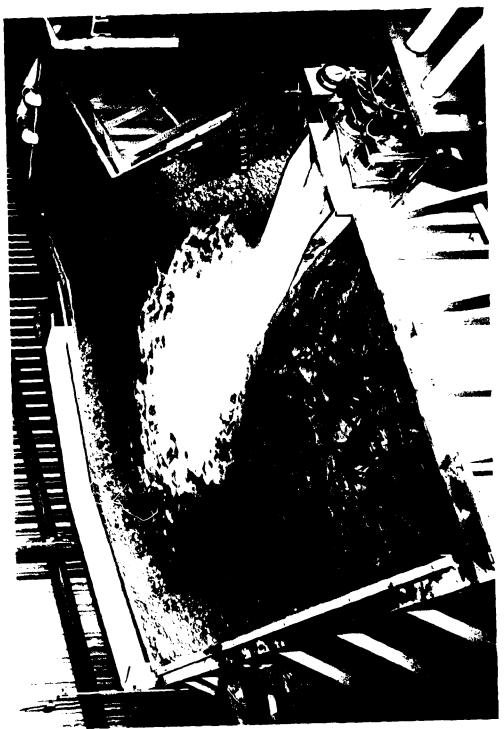
Photo 6. Increased tailwater design, type 11 basin. Flow conditions at pool el 1088, 28.1-in. sleeve travel, tailwater el 518

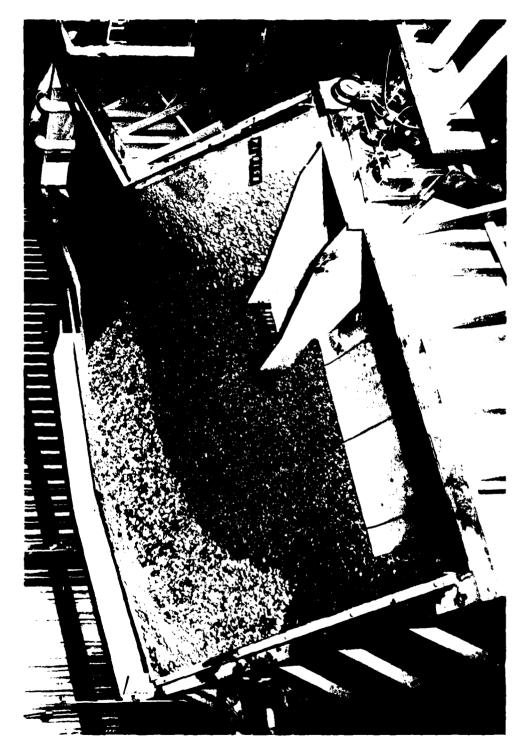
el 518 (Photo 6). The dry bed condition after testing is shown in Photo 7; note the rather limited extent of bottom scour and stable opposite bank.

Photo 7. Increased tailwater design, dry bed after flow shown in Photo 6

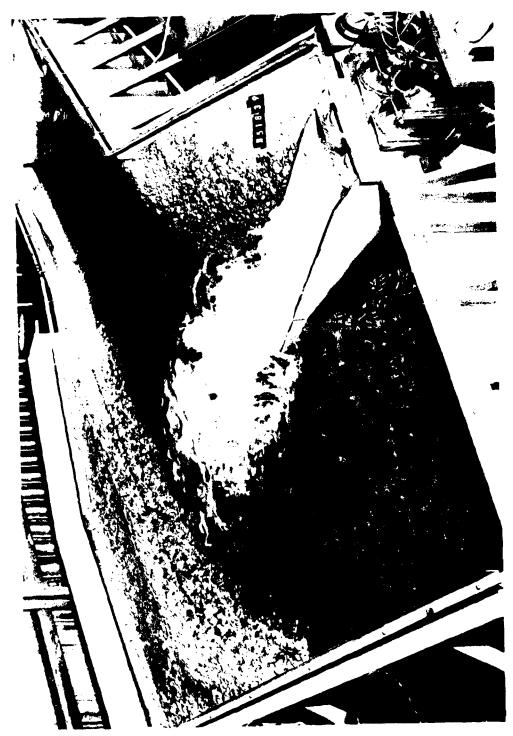
Same flow as in Photo 9, Photo 9. Recommended deflector plate design. Same showing attack on opposite bank

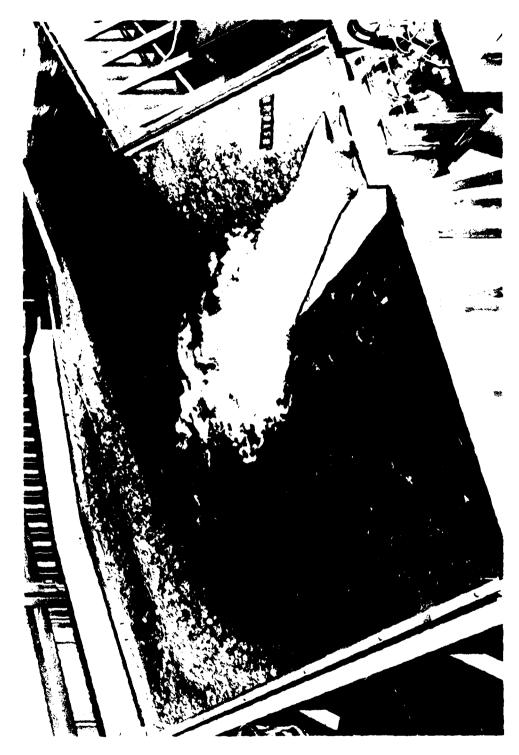
Photo 10. Recommended deflector plate design. Flow at pool el 1088, 28.1-in. sleeve travel, tailwater el 511

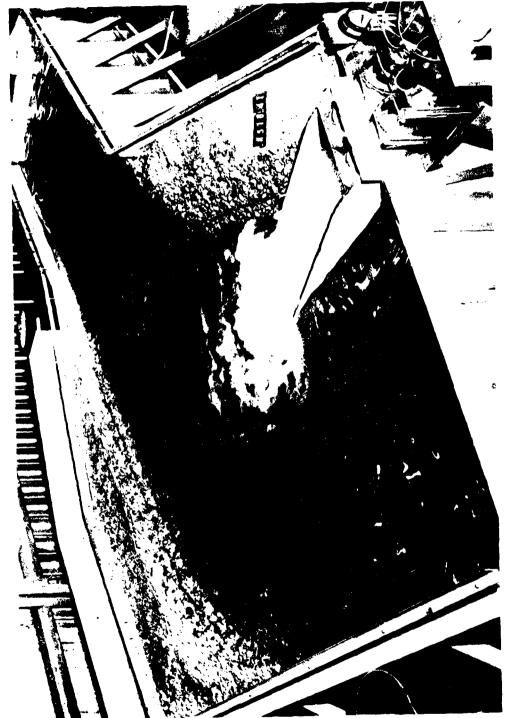
Photo 11. Recommended deflector plate design. Flow at pool el 800, 28.1-in. sleeve travel, tailwater el 511

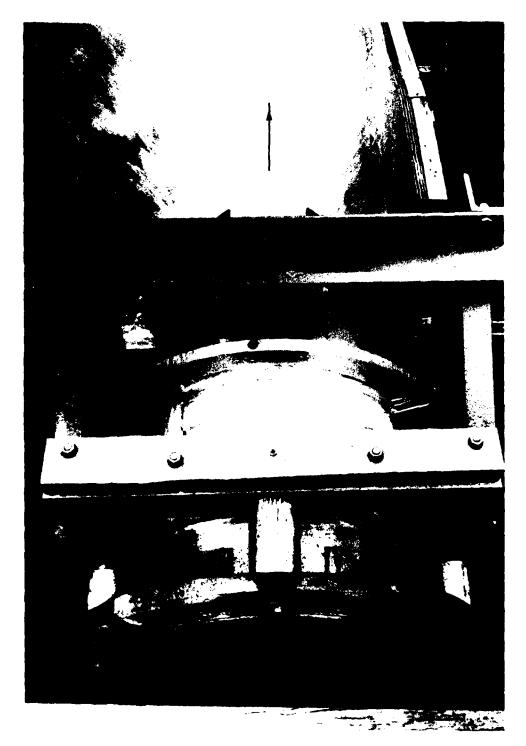
Photo 13. Recommended deflector plate design. Top view of flow conditions in 1:12-scale model
